Dier & Dijk: Diepgravende inzichten om grote gaten te voorkomen

Daan Bos

UNIE VAN
WATERSCHAPPEN

Altenburg & Wymenga

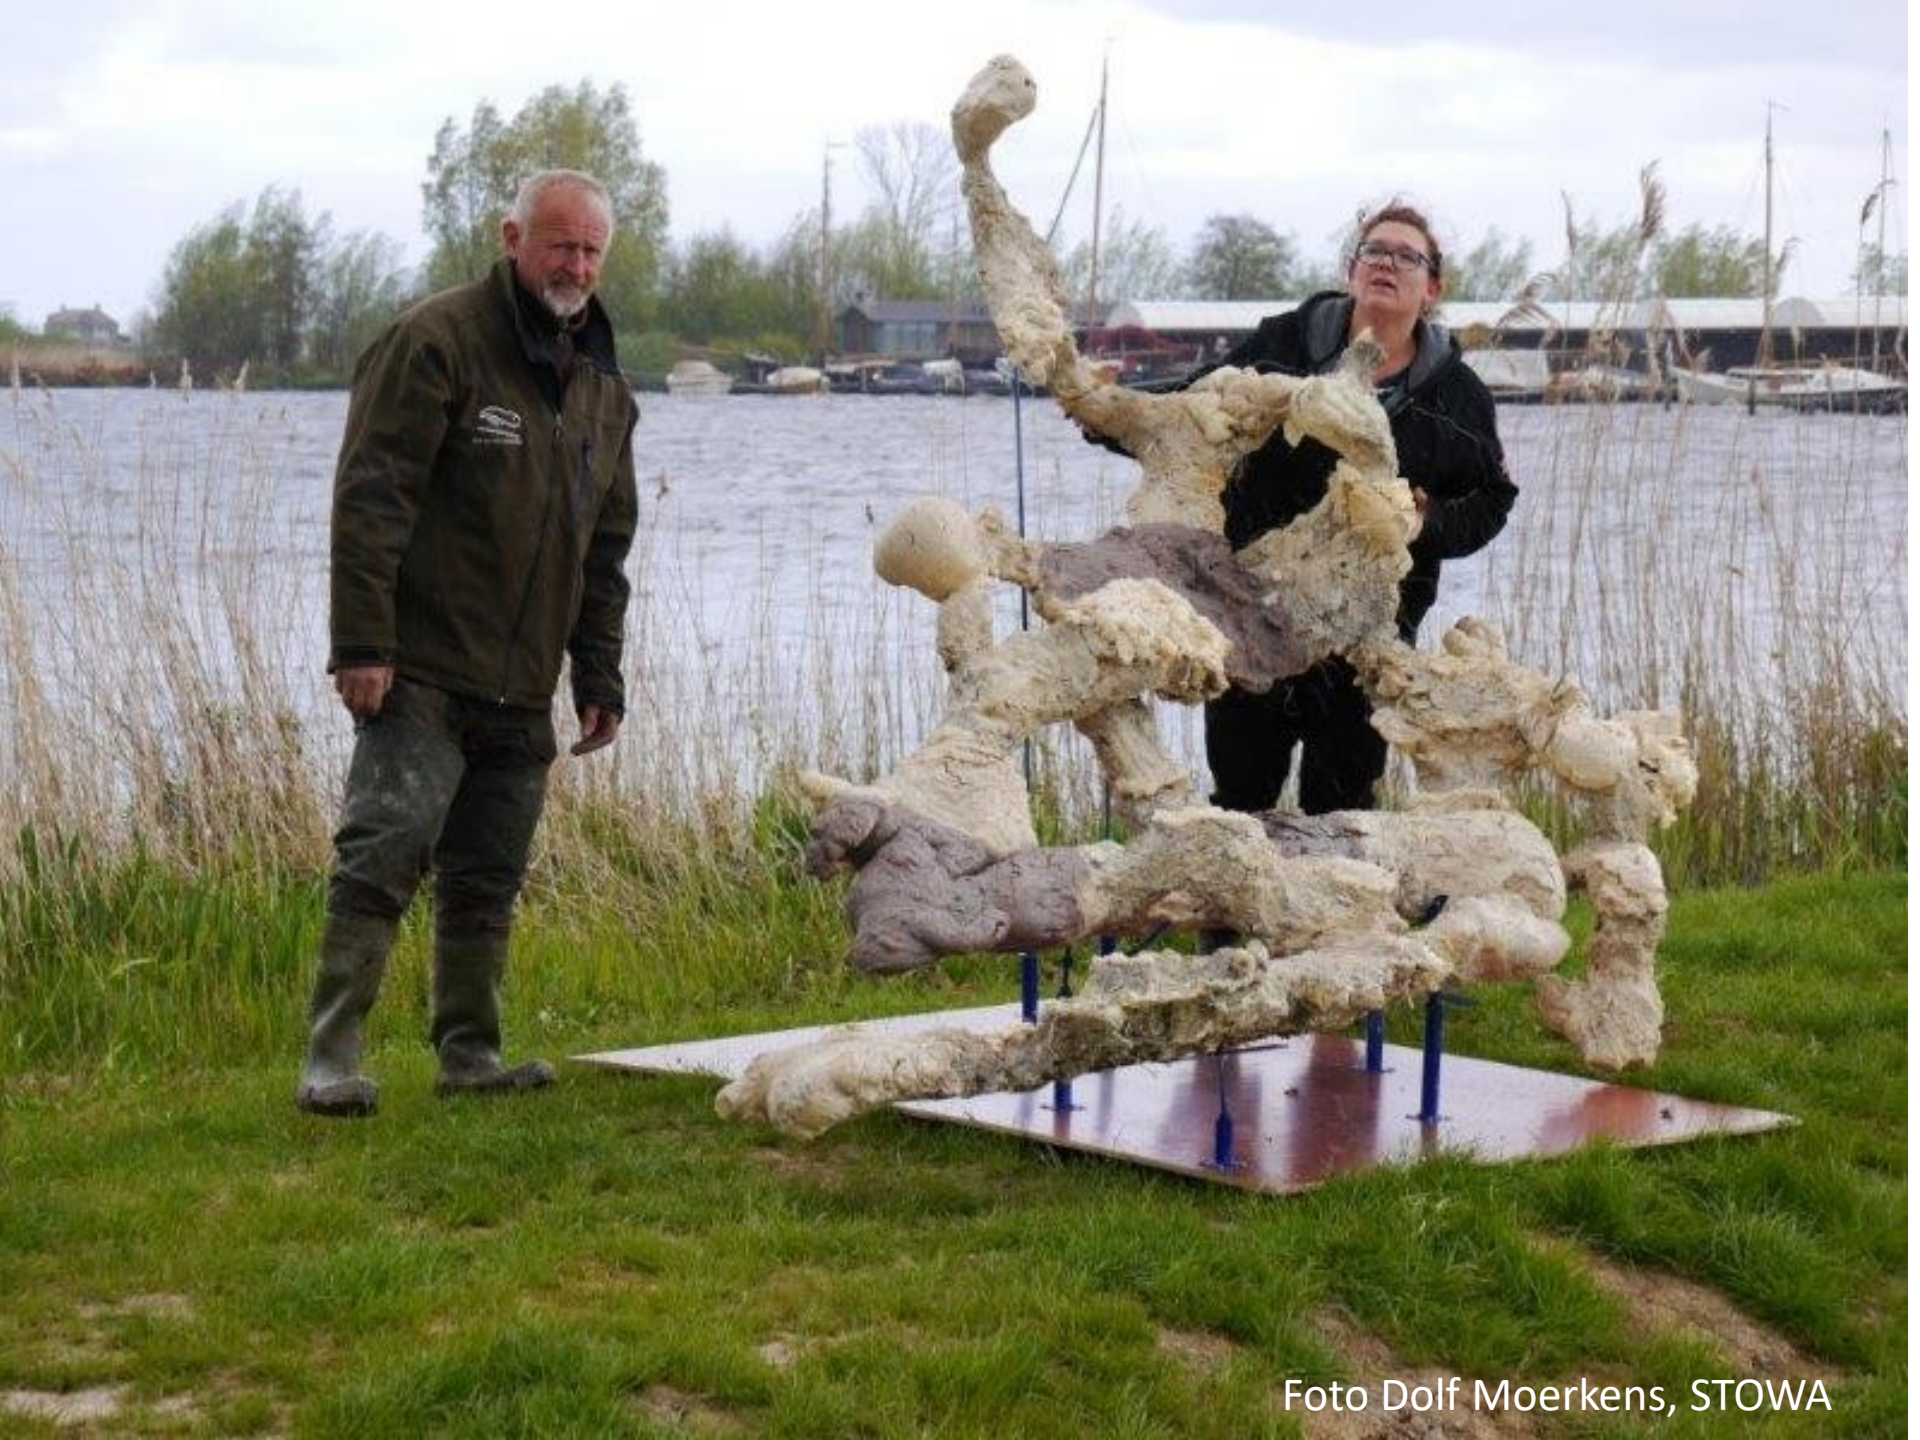
Foto Dolf Moerkens, STOWA

Bevergaten zijn zo groot dat Hansje Brinkers niet alleen zijn vingertje in de dijk moet steken.....

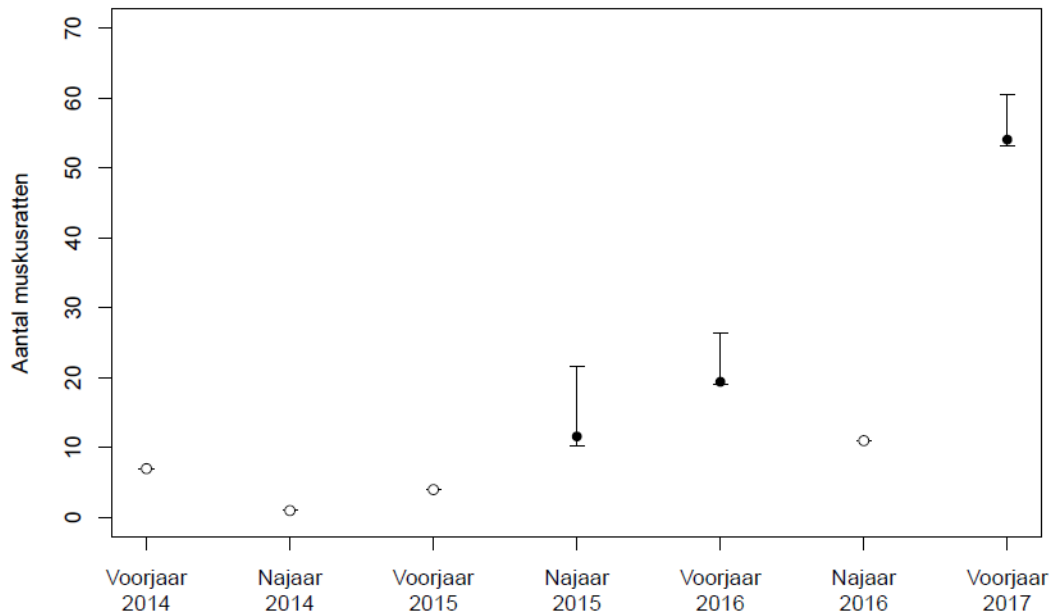
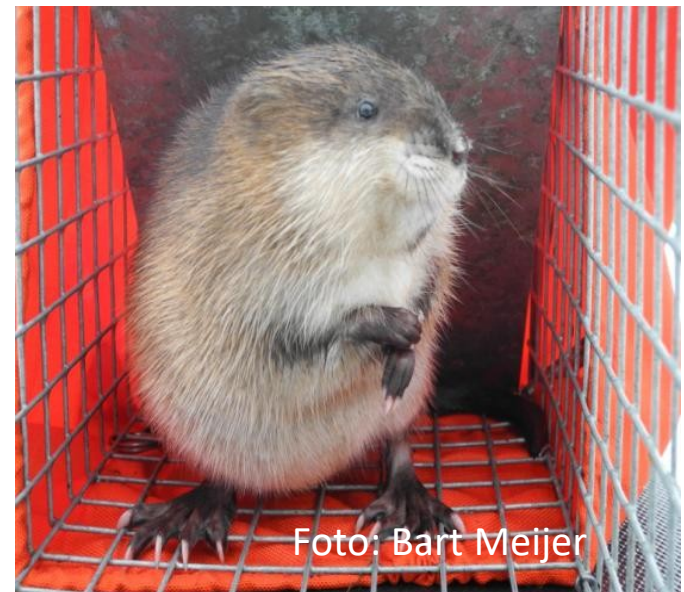
Het aantal schades –groot en klein- houdt verband met de vangsten in het recente verleden.

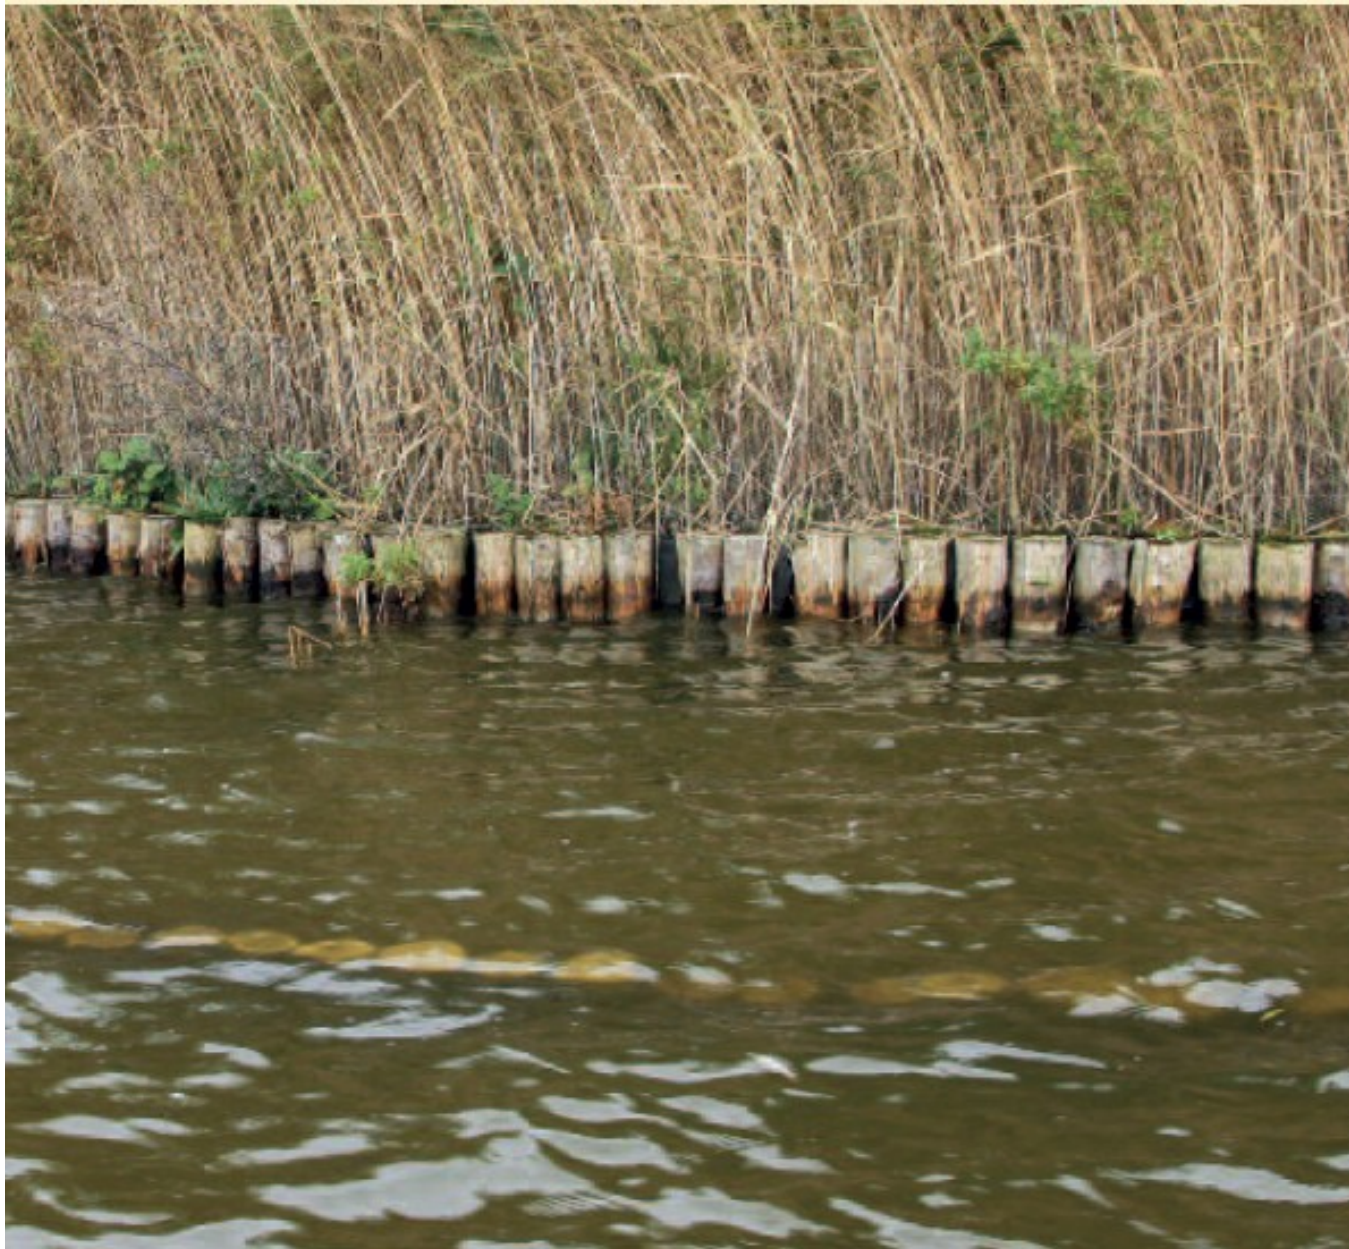
Standaard oeverbescherming is onvoldoende

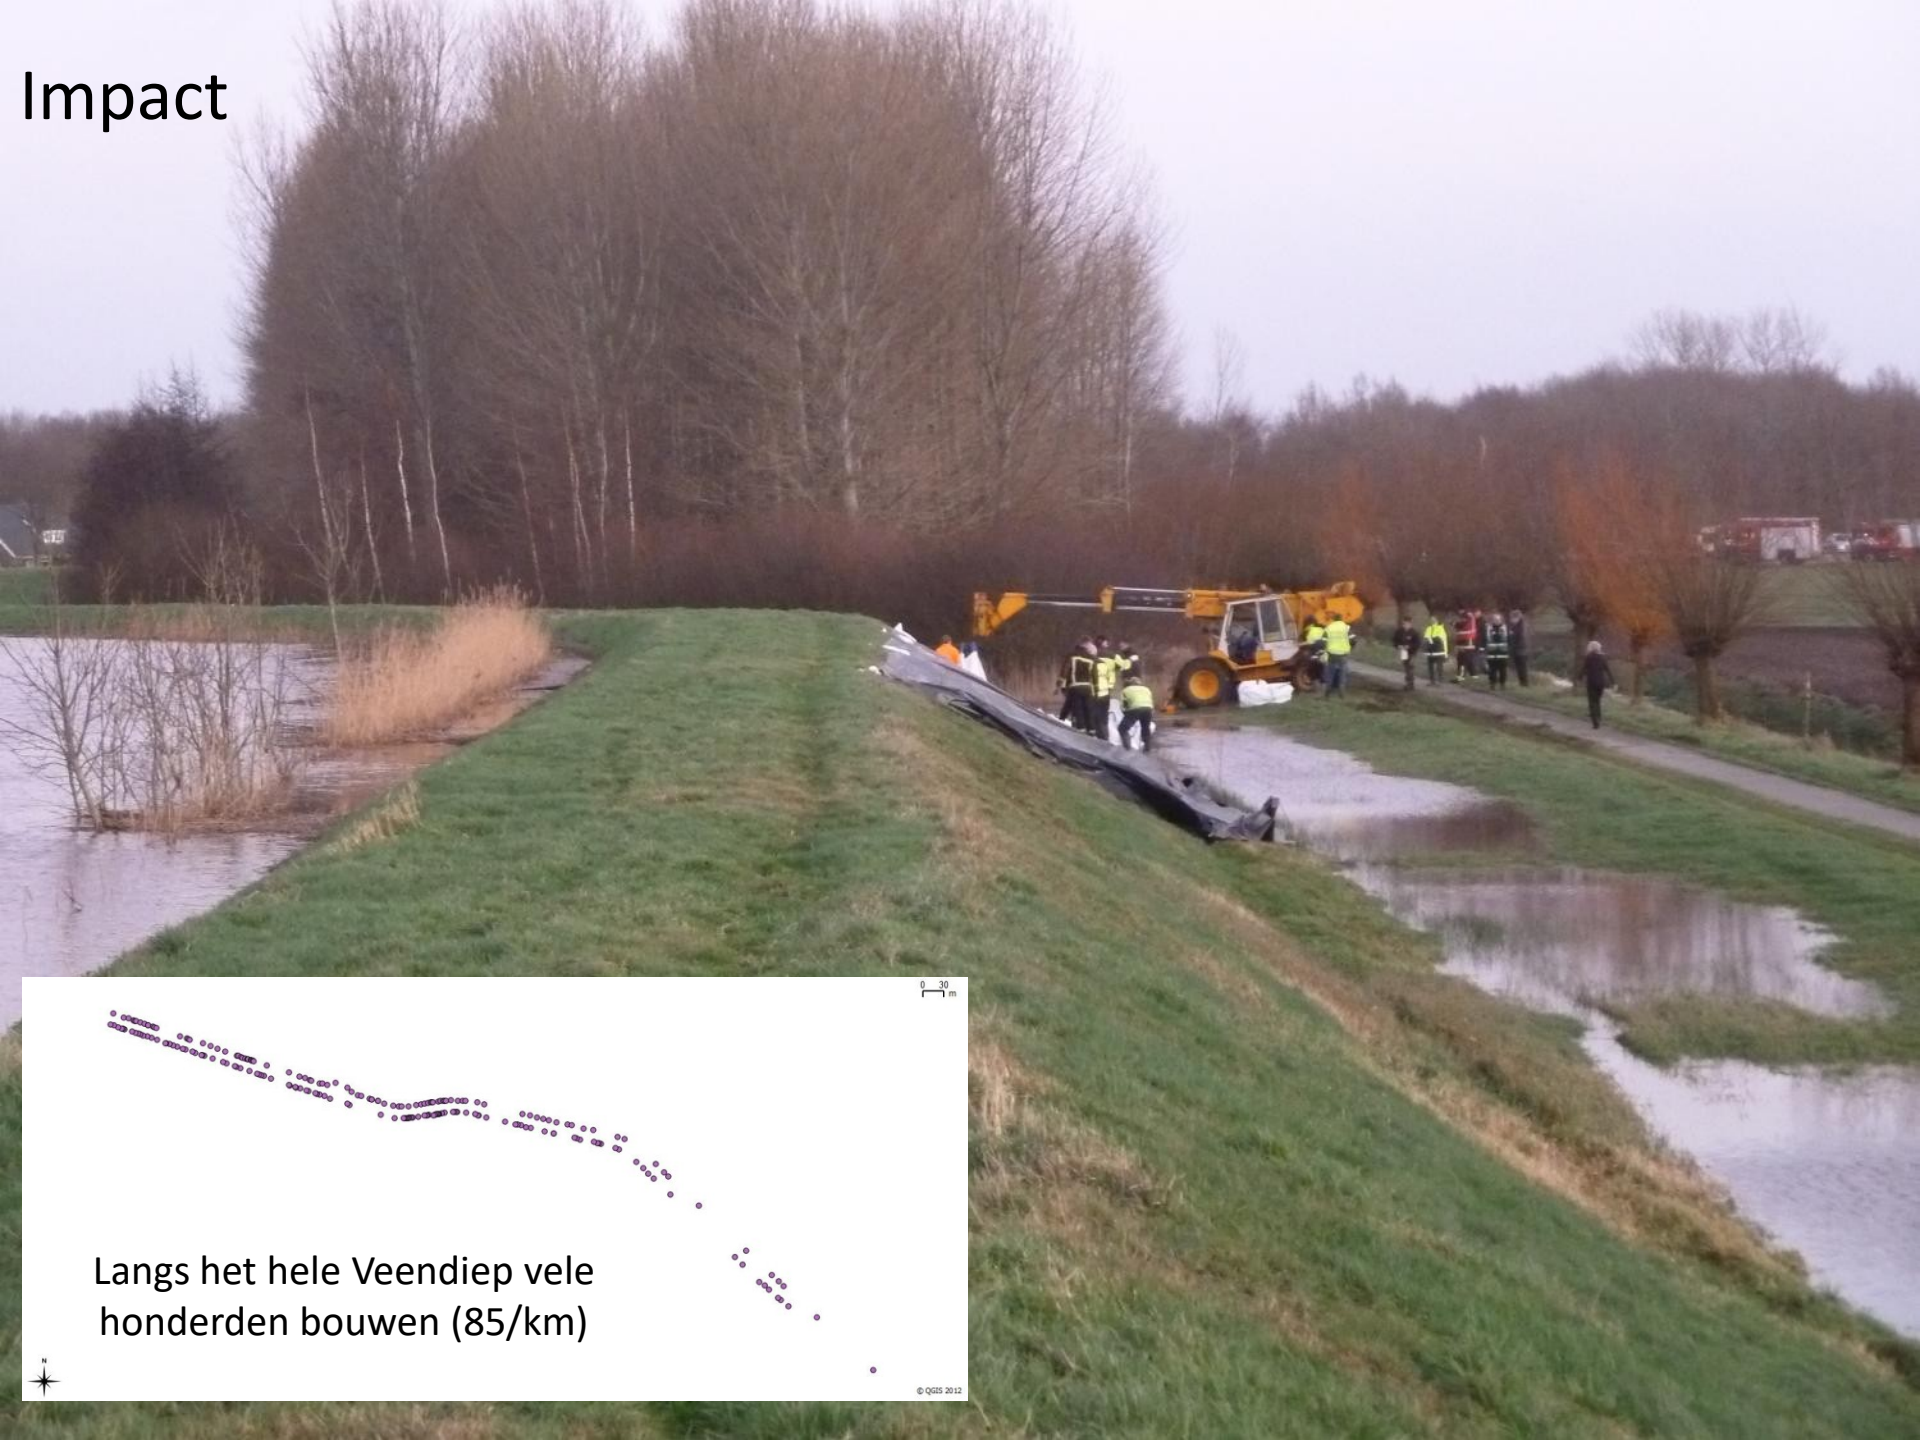
Langs het hele Veendiep vele honderden bouwen (85/km)
